TECHNICAL NOTES

Improvement of Pulse-mode Photographic Images In MDS Computer Systems

Michael F. Gard and Charles R. Morris

J Nucl Med 20: 789-790, 1979

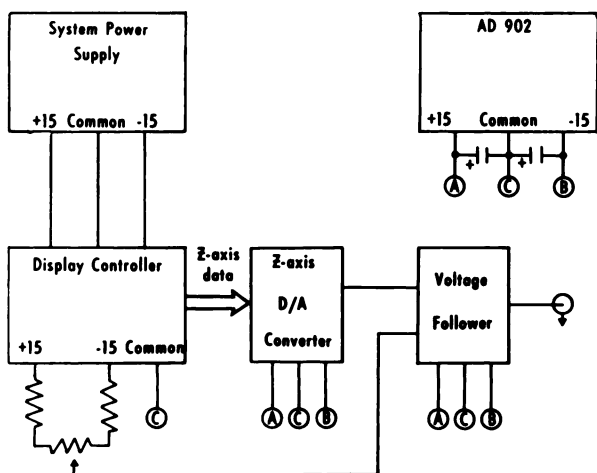
FIG. 2. Schematic of modification. Accessory power supply and its connection to existing circuitry are indicated.

The solution to the problem is the complete isolation of the power-supply lines to the Z-axis D/A converter from the rest of the system. This is done most simply by installing a small modular power supply that provides ± 15 -Vdc power only to the Z-axis D/A converter and its associated voltage followers. The power supply used by us was an Analog Devices Model 902, which provides ± 15 Vdc at up to 100 mA per side, but any well-regulated and well-filtered power supply with this current rating would be adequate. As an extra precaution, both the +15- and the -15-Vdc outputs were bypassed to the power supply common with 0.1 μ F solid tantalum capacitors. A schematic diagram of the modification is shown in Fig. 2.

1. Mount the power supply as close as possible to the Z-axis D/A converter. We were able to mount our power supply on perforated board in space previously unused and immediately adjacent to the Z-axis converter.

2. Keep the ± 15 -Vdc power-supply leads as short as possible. This not only reduces the possibility of catching these leads when the display-controller tray is moved, but it also reduces the possibility of noise pick-up from any source. If the physical arrangement of a particular system requires longer leads (>6-8 in.), it is recommended that additional bypass capacitors (e.g., 0.1- μ F ceramic discs) be installed at the power-supply pins of the Z-axis D/A converter.

3. Keep the 120-V ac power leads well removed from the ± 15 -Vdc output leads.
4. Connect the power-supply's common line to the display driver circuit at only one point, preferably at the Z-axis D/A converter ground pin.
