Phantom Feet on Digital Radionuclide Images and Other Scary Computer Tales

John E. Freitas, Howard J. Dworkin, Stuart M. Dees, and Richard Ponto

Nuclear Medicine Department, William Beaumont Hospital, Royal Oak, Michigan

J Nucl Med 30:1559-1562, 1989

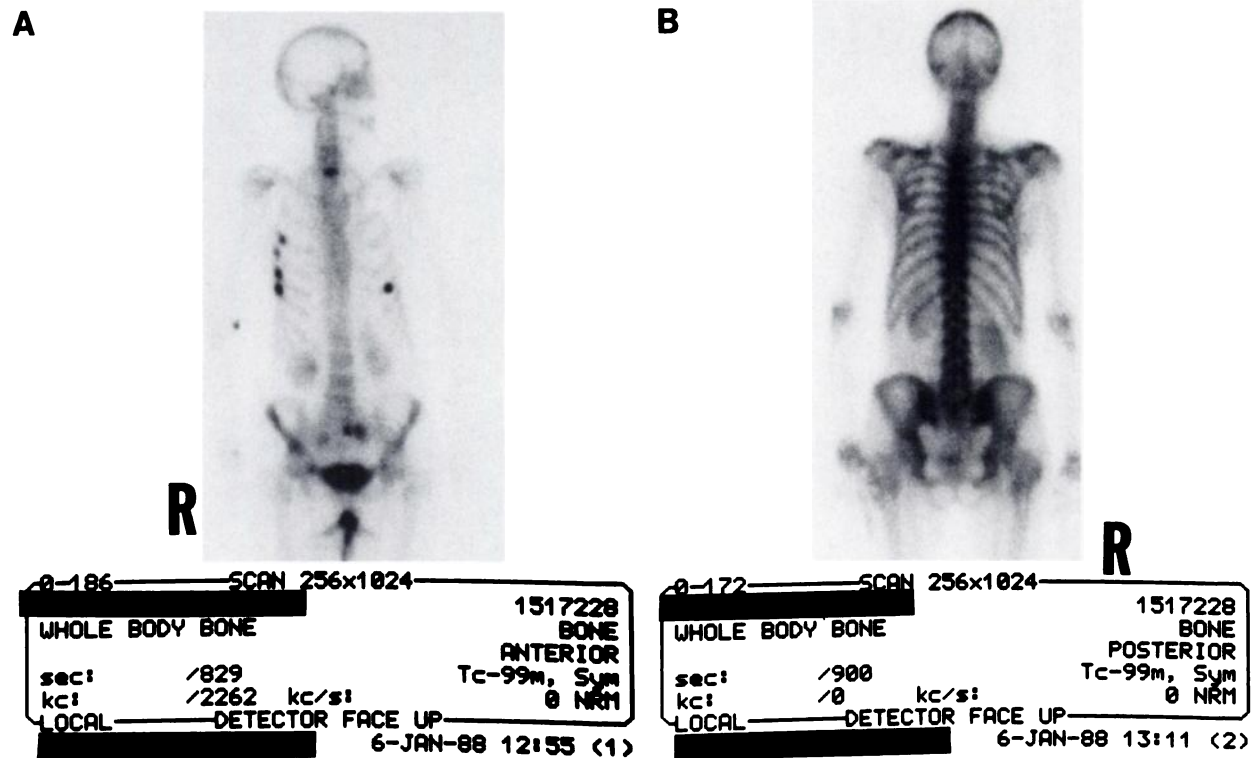
Following the i.v. administration of 21.7 mCi (803 MBq) of technetium-99m methylene diphosphonate (^{99m}Tc]MDP), anterior and posterior whole-body scans were performed utilizing the computer assisted digital gamma camera. The protocol used for the acquisition was set up following directions provided by the vendor and is shown in Table 1. The images were recalled for display using the standard function available on the system, i.e., activating the LOAD function switch to retrieve data sets for the current patient. The anterior and posterior head to mid-femur images are presented in Figure 1. These images were initially recorded immediately after the bone scan. On review of the images, the abnormal right rib and left sacroiliac radioactivity seen on the anterior image unexpectedly did not give rise to analogous abnormal areas on the posterior image despite having the same patient name. Also, the posterior image was that of a markedly different body habitus. An attempt to "call up" this bone scan yielded the image seen in Figure 2. The fractured ribs and sacrum (and other abnormalities) seen in Figure 2 were confirmed on subsequent x-rays.

FIGURE 1
 Bone scan. Initial images at 2-hr postradiopharmaceutical administration. A: Anterior view. Note increased uptake of tracer in right ribs and left sacroiliac region. B: Posterior view. Note lack of corresponding uptake in rib and sacroiliac regions. Body habitus differs from the anterior view and from that of patient in A (height 62 in.; weight 104 lb)

identification text was observed again on January 11, 1988. In order to avoid further errors and to correctly identify each patient, a "hot" marker was introduced in each image. The "hot" marker was placed next to the patient's head for the

first scan of the day and indexed a few centimeters caudally for each subsequent patient on that day. Therefore, the "hot" marker appeared in the same relative position on both the anterior and posterior image for each patient.

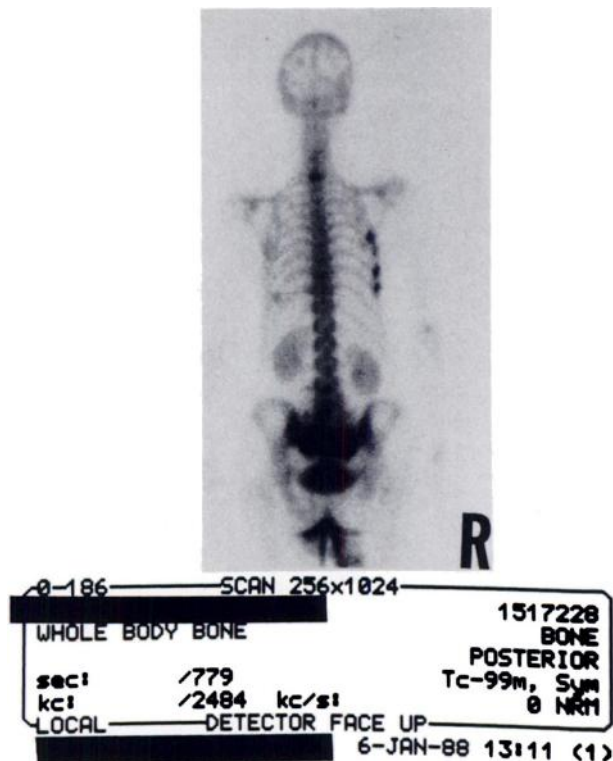
FIGURE 2
Bone scan. Posterior view as retrieved from disk file for patient in Figure 1A.

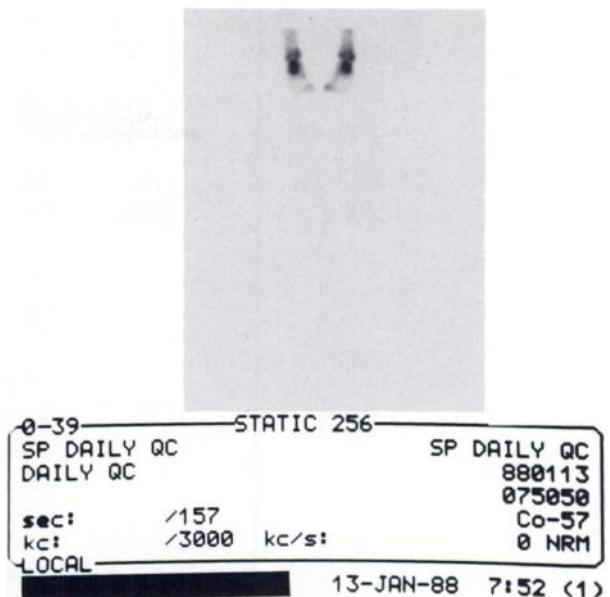
On January 13, 1988, after completing the morning routine daily camera system quality control procedures, the technologist left to develop the film. On return, a pair of "phantom feet" was seen on the screen (Fig. 3), along with the text from the QC procedure.

FIGURE 3
Routine QC text and phantom feet which appeared spontaneously.

On April 29, 1988, the entire console was replaced by the vendor. Since then, the problem of switching images and patient identification text has not been observed. Hopefully,
