SUPPLEMENTAL FIGURE 1:

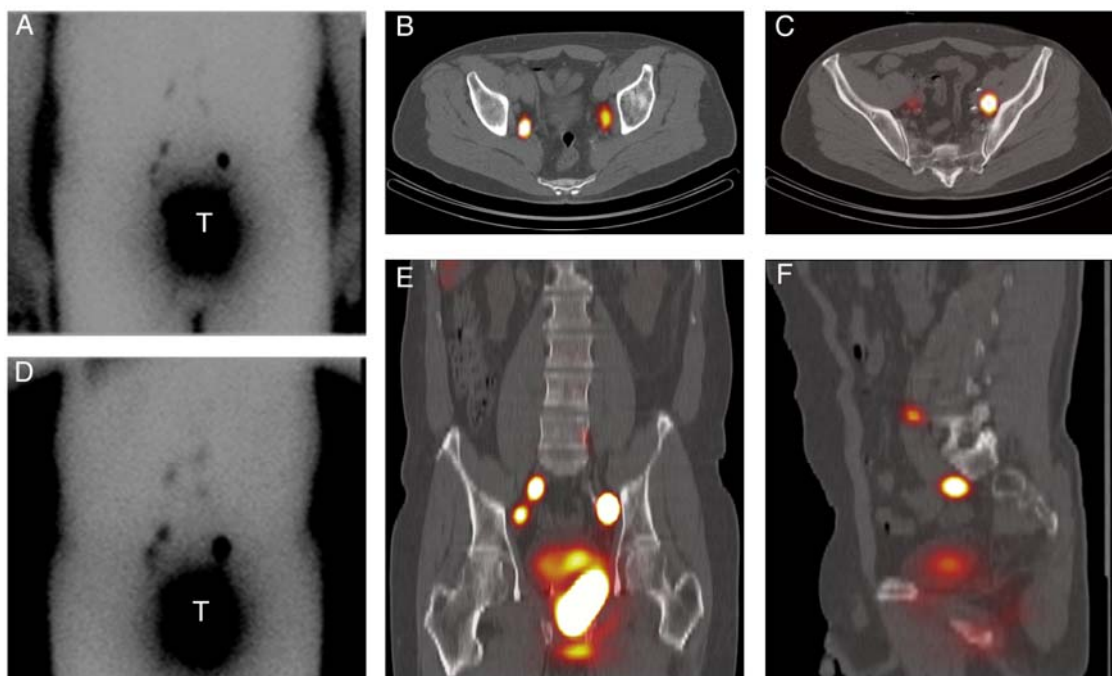
A: The planar lymphoscintigraphy at 15 minutes (A) and 2 hours (D) showing bilateral pelvic drainage. The lymph nodes located proximal to the injection site (T) are identified as sentinel nodes.

Axial fused SPECT/CT (B) shows localisation of one sentinel node in each obturator fossa. These nodes lie behind the injection area and are not seen on planar images. Coronal section (E) shows localisation of two more cranially located sentinel nodes on the right and one on the left. This left sentinel node of the coronal section is clearly shown at the level of the common iliac artery (E). On the axial image the atherosclerotic calcifications in this artery are visible (C). The sagittal image (F) also shows the common iliac artery and the sentinel node lying alongside it. On this image also a para-aortic second echelon node is visible.
