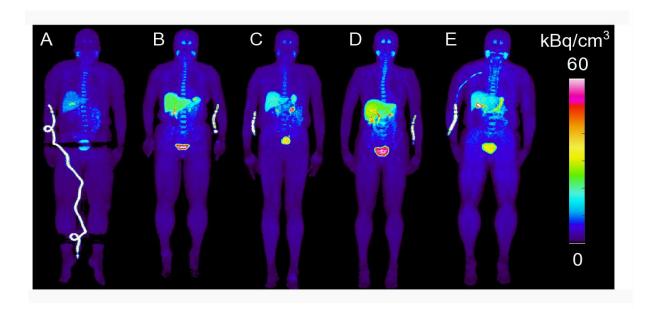
SUPPLEMENTAL FIGURE 1. Maximum Intensity Projection images of the five participants scanned at 40 min p.i. ¹⁸F-FE-PE2I is a lipophilic substance which sticks to the wall of the plastic injection tube. As can be seen in figure A, a long injection tube was used for participant 1. Because of high activity in the injection tube, artefacts occurred (black lines in the figure A) due to saturation of the detectors in the PET-camera. Shorter injection tubes were used for the other participants, in order to minimize this effect.
