Do Implanted Pacemaker Leads and ICD Leads Cause Metal-Related Artifact in Cardiac PET/CT?

Frank P. DiFilippo, PhD; and Richard C. Brunken, MD

Department of Molecular and Functional Imaging, Cleveland Clinic Foundation, Cleveland, Ohio

J Nucl Med 2005; 46:436–443

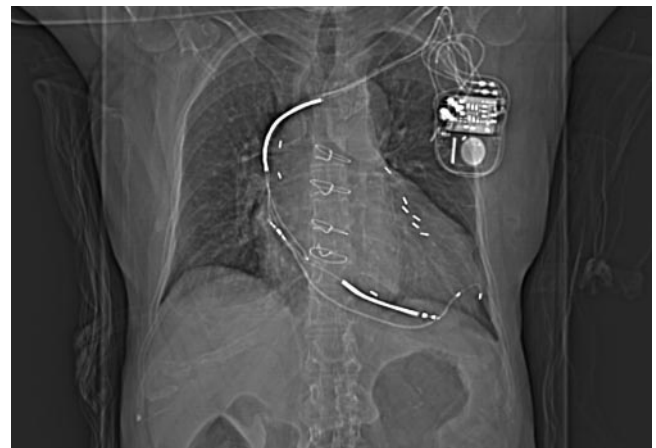
FIGURE 1. Topogram image of patient study shows ICD/pacing device, ICD lead with dual shock coils, and pacing lead with electrodes implanted in left ventricle. Sternal wires and surgical clips are visible from prior surgical procedure.

cause noticeable artifacts in the PET/CT images. Our discussion on metal-related artifact therefore focuses on the electrodes and shock coils, and not the conductor wires. Other metal objects of similar size and density, such as sternal wires and surgical clips (Fig. 1), were not observed to cause PET/CT artifacts. We also infer that other small metal implants of similar atomic number and density, such as stents made of nitinol (an alloy of nickel and titanium), would not cause significant artifacts.

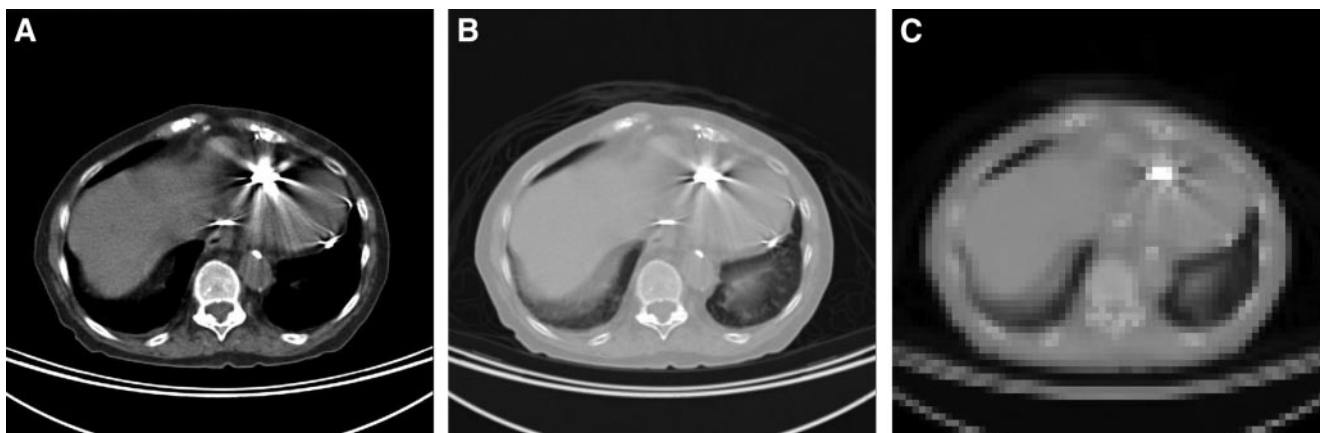
FIGURE 3. CT slice images correspond to topogram image in Figure 1, illustrating relative intensities of artifacts from ICD lead and pacing leads. (A) CT image with body window. (B) CT image with lung window. (C) Filtered and down-sampled image used for PET attenuation correction.

As noted in both the phantom images (Fig. 2) and the patient images (Fig. 3), the radioopaque platinum electrodes cause substantial CT artifacts, especially the larger-sized ICD shock coils. Although the CT artifacts are intense, the factor of greater concern is their impact on the attenuation correction of PET data. After the CT-to-PET scaling algorithm is applied, the attenuation map derived from the CT image is filtered and down-sampled from a 512×512 matrix to a 128×128 matrix. These processing steps serve to minimize the degree of artifact in the attenuation map. In the patient example in Figure 3 (right), the pacing electrode is not prominent in the attenuation map, whereas the ICD shock coil is still clearly seen. This observation is consistent

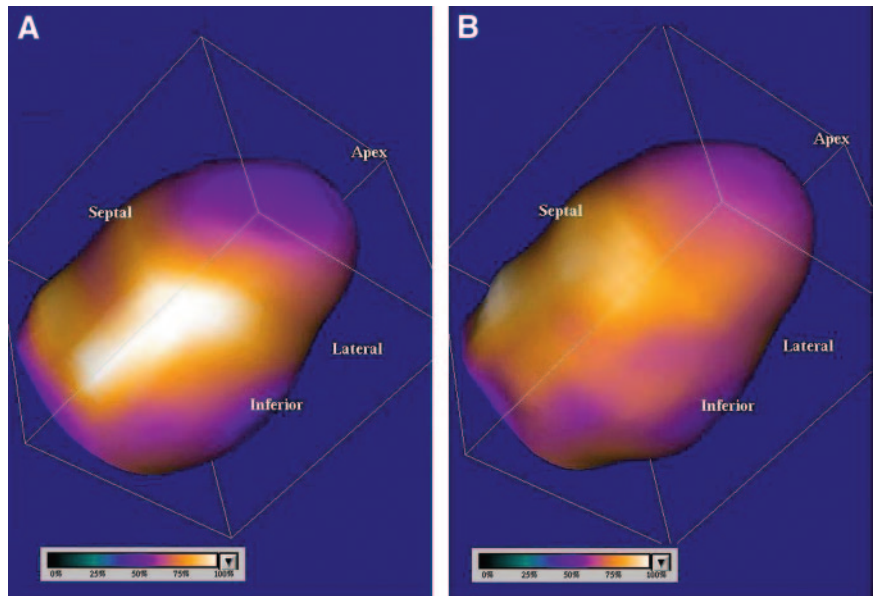
FIGURE 4. Three-dimensional renderings of segmented left ventricle, with color scale indicating relative ^{18}F -FDG uptake. Metal artifact related to implanted ICD lead near inferoseptal wall is easily seen by comparing PET/CT data (A) with PET data (B).

For the ICD leads (10 patients), significant artifact arising from CT-AC was observed on PET/CT images in 5 cases (50%), whereas no significant artifact was observed in the other 5 cases (50%). The artifact is clearly identifiable in surface rendered images of the left ventricle, as illustrated in Figure 4. The artifacts were all noted in the inferoseptal region of the left ventricle, as ICD shock coils typically are placed in the right ventricle near that region. The magnitude of the CT-AC-related artifact was measured from the circumferential profiles of the polar maps, relative to adjacent regions (Fig. 5). In the 5 PET/CT studies with artifact, the apparent ¹⁸F-FDG uptake at the lead location was 44%–

An interesting observation was that in many cases with metal-related PET/CT artifact, there was a small increase in local uptake on the PET images, which mirrored the spatial location and extent of the ICD shock coil (Fig. 4). This effect was not an artifact of transmission source attenuation correction, since the lead was not visible in the transmission

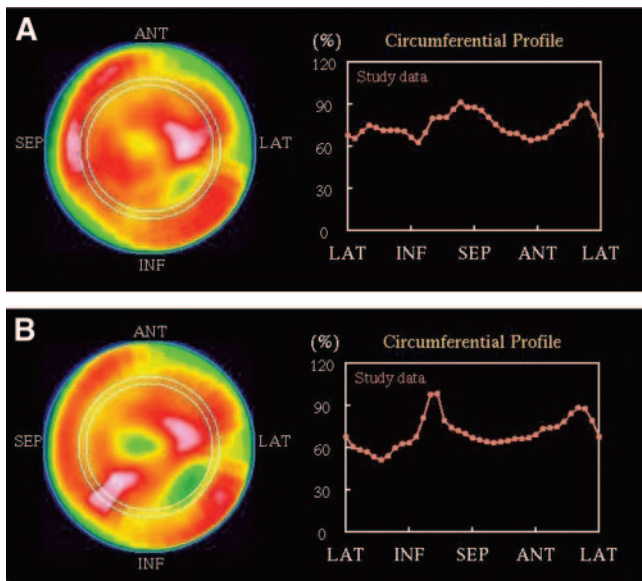
FIGURE 5. PET (A) and PET/CT (B) polar maps and circumferential profiles illustrate PET/CT metallic artifact from ICD lead. ANT = anterior; SEP = septal; LAT = lateral; INF = inferior.

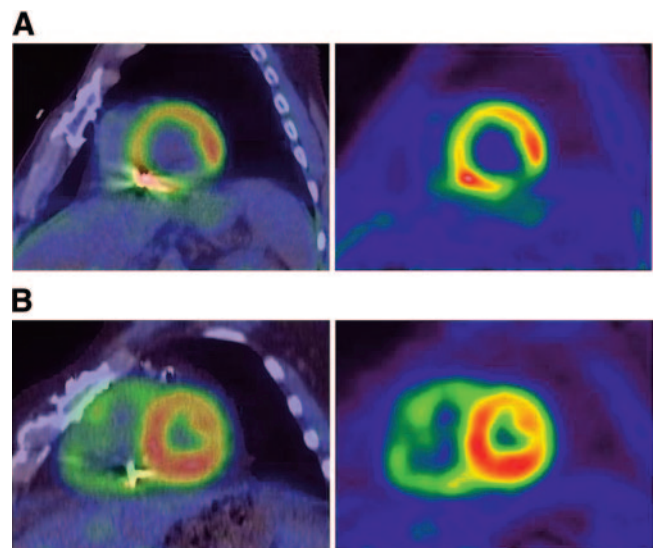
FIGURE 6. Fused PET/CT and PET images (short-axis views) from 2 studies show variation in ICD lead placement. Distance from shock coil to left ventricle is 0 mm in top images (A) and 20 mm in bottom images (B). Note different impact on left ventricular regional uptake depending on shock coil proximity.

Fused short-axis images (Fig. 6) demonstrated variation in the proximity of the ICD shock coil to the left ventricle. Measurements of the distance between the shock coil and the left ventricular wall were correlated with the presence or absence of metal-related artifact (Fig. 7A). However, no

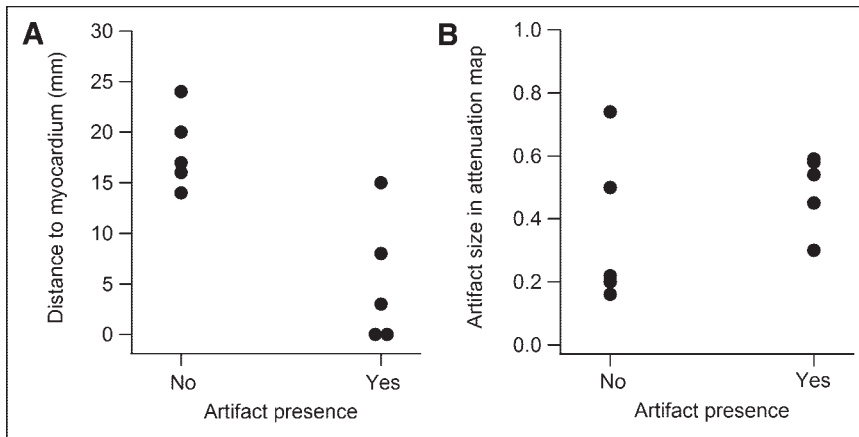
FIGURE 7. Plots of measured distance from ICD shock coils to left ventricle (A) and magnitude of corresponding artifact in CT-AC attenuation maps (B), with respect to presence or absence of metal-related artifact in PET/CT images.

relationship to the magnitude of the CT artifact was observed (Fig. 7B).

PET/CT artifacts relating to the ICD leads were clearly identifiable in the phantom images, but such artifacts were seen in some, but not all, patient studies. One might anticipate that the presence of metal-related PET/CT artifacts is related to the magnitude of the artifact in the CT-based attenuation maps. Due to variations in electrode design (metal composition, wire thickness, coil dimensions, and so forth), certain models of shock coils produce more intense CT artifacts than others. In addition, the magnitude of CT artifact may also be affected by the lead placement, CT acquisition parameters, patient girth, and respiratory and cardiac motion. However, no significant correlation between the magnitude of attenuation map artifact and the presence of PET/CT artifact was found (Fig. 7B).
